# Fire in the Cockpit: The Apollo 1 Tragedy

Leadership ViTS Meeting  
February 2008

Bryan O' Connor  
Chief, Safety and Mission Assurance

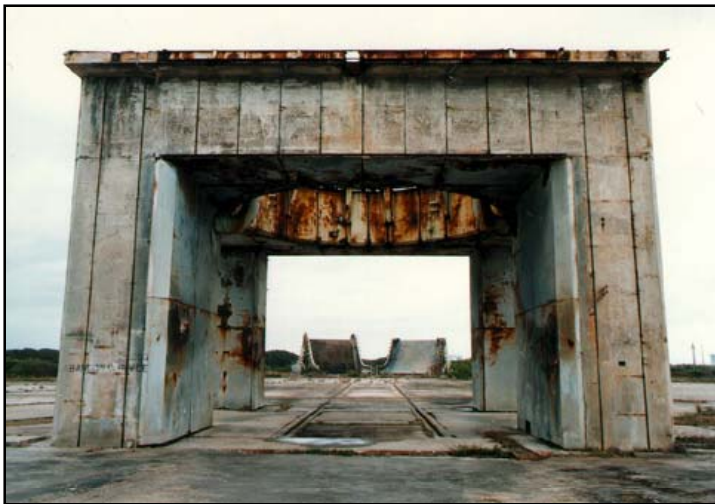
Pad 34 – site of the Apollo 1 fire.

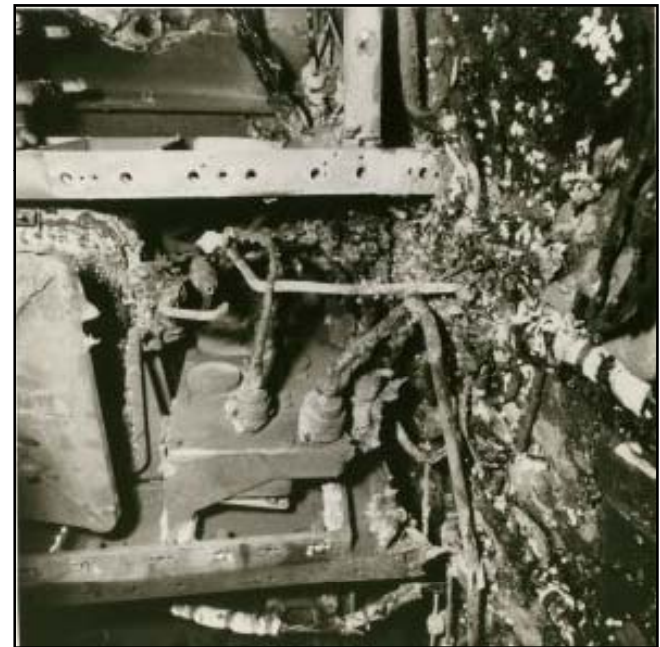
- Teflon was specifically chosen for the wire coating due to its excellent insulation, chemical inertness and fire resistance. However, Teflon is soft and therefore susceptible to creep, or cold-flow deformation, and abrasion. The Teflon coating had worn away during operations, exposing the electrical wiring.

Wires where the fire is believed to have started.

- A spark caused by an electrical short in a 100% oxygen atmosphere set fire to an abundance of flammable material.
